# Test Report

Report No. A2230007151101002

Sample Name T-BAT-SYS-HV-S3.6

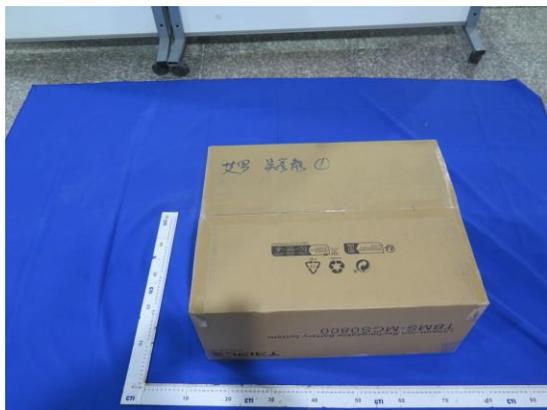
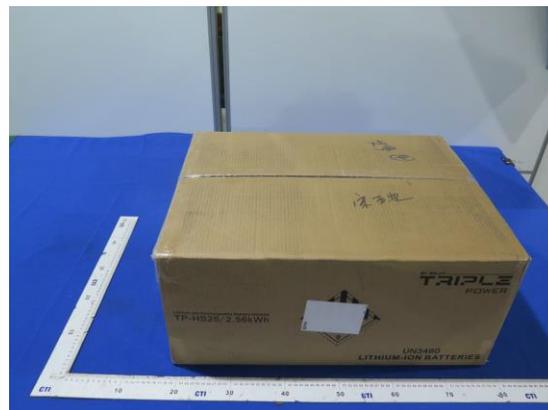
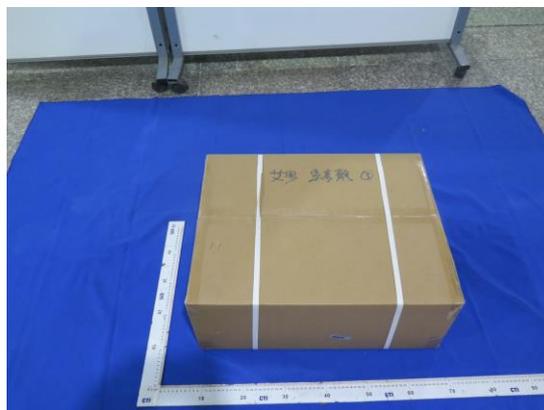
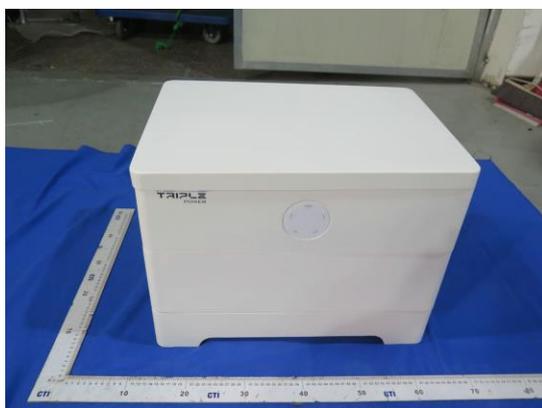
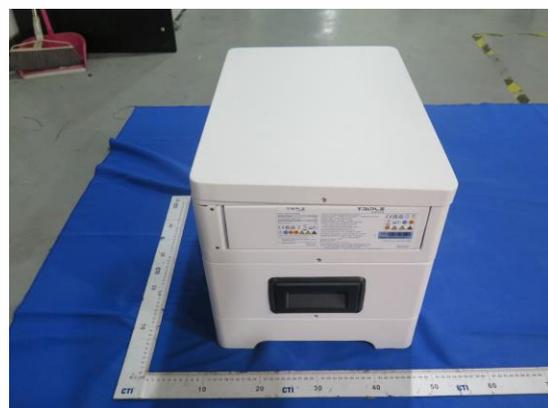
A2230007151101002 (package)

**Sample Photo(s)**

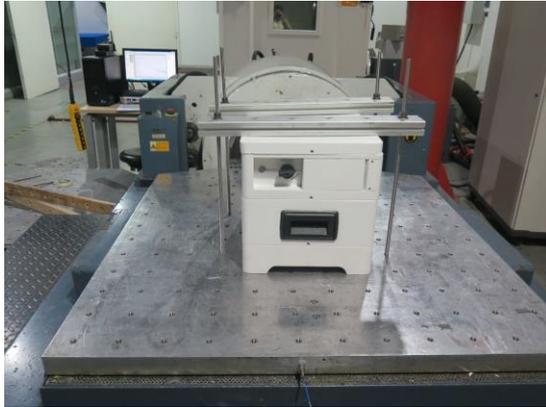
X

Sample No.	Test Result(s)
A2230007151101002	After the test, there was no visible mechanical damage on the sample by visual inspection.

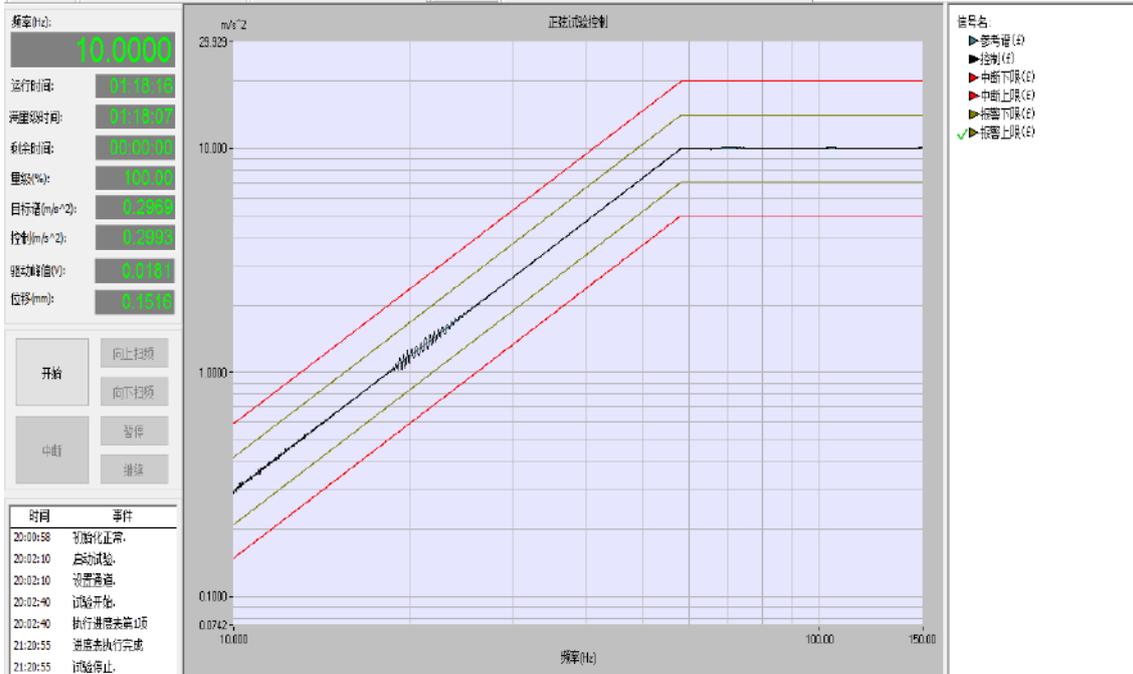
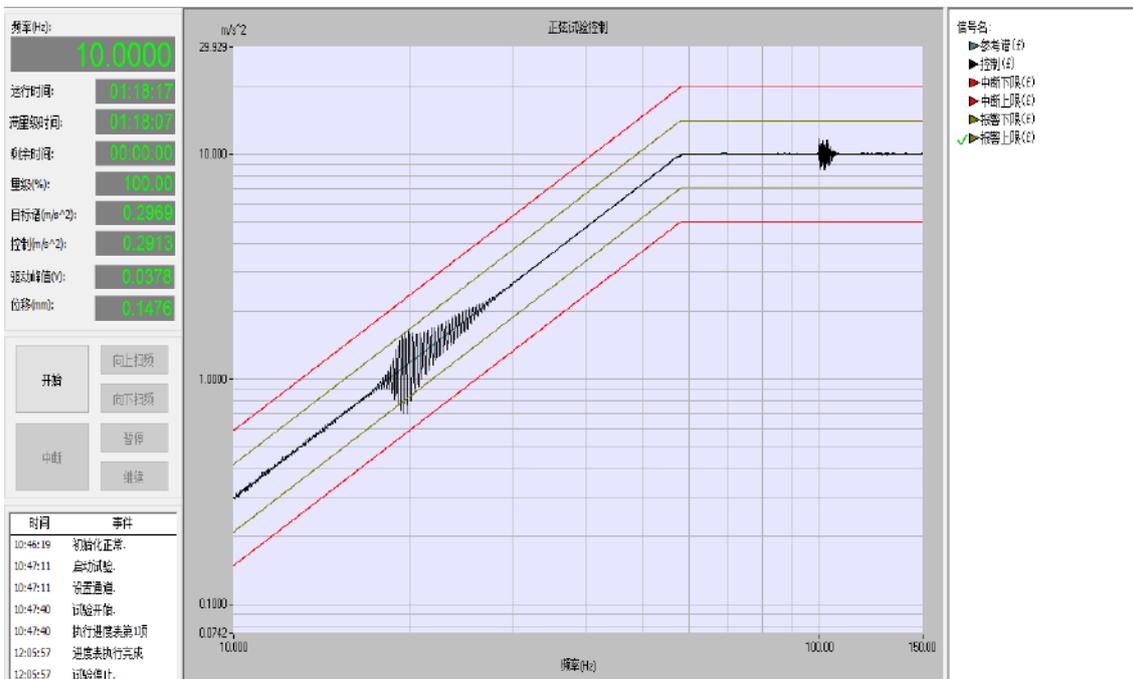
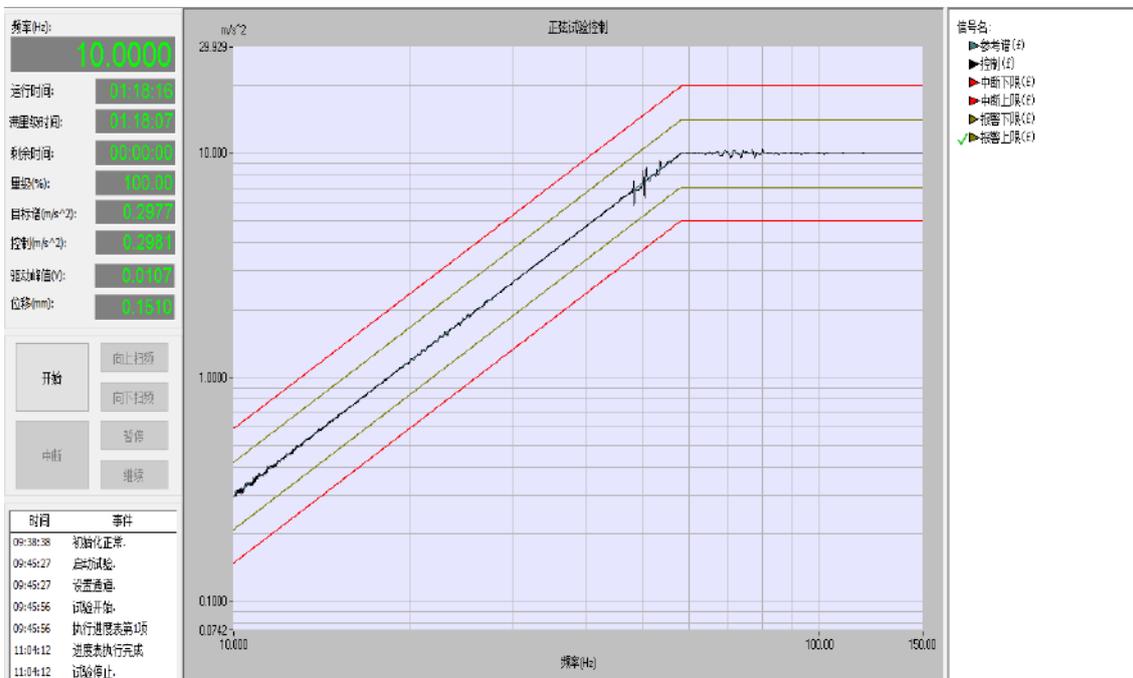
### Test Curve

Frequency (Hz)	Acceleration (m/s <sup>2</sup> )	Amplitude (mm)	Test Direction	Test duration
10-58	/	0.075	X、Y、Z	10cycles/axis
58-150	10	/		
Sweep rate: 1oct/min

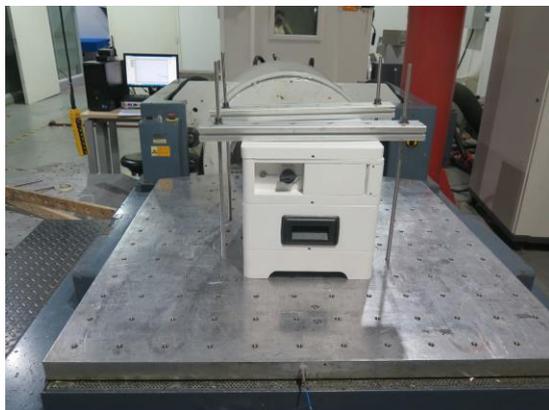
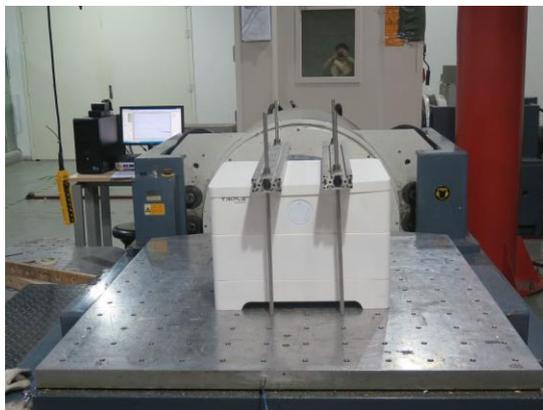
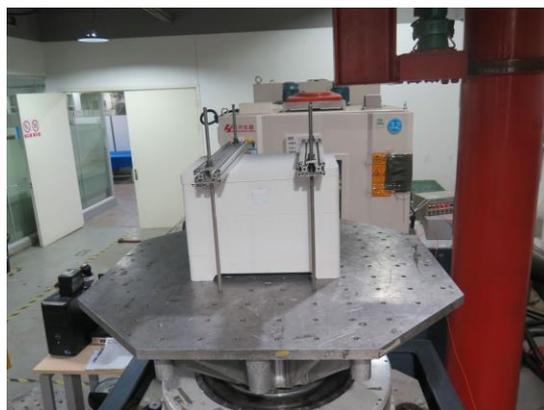
## Test Photo(s)

Sample No.	Test Result(s)
A2230007151101002	After the test, there was no visible mechanical damage on the sample by visual inspection.

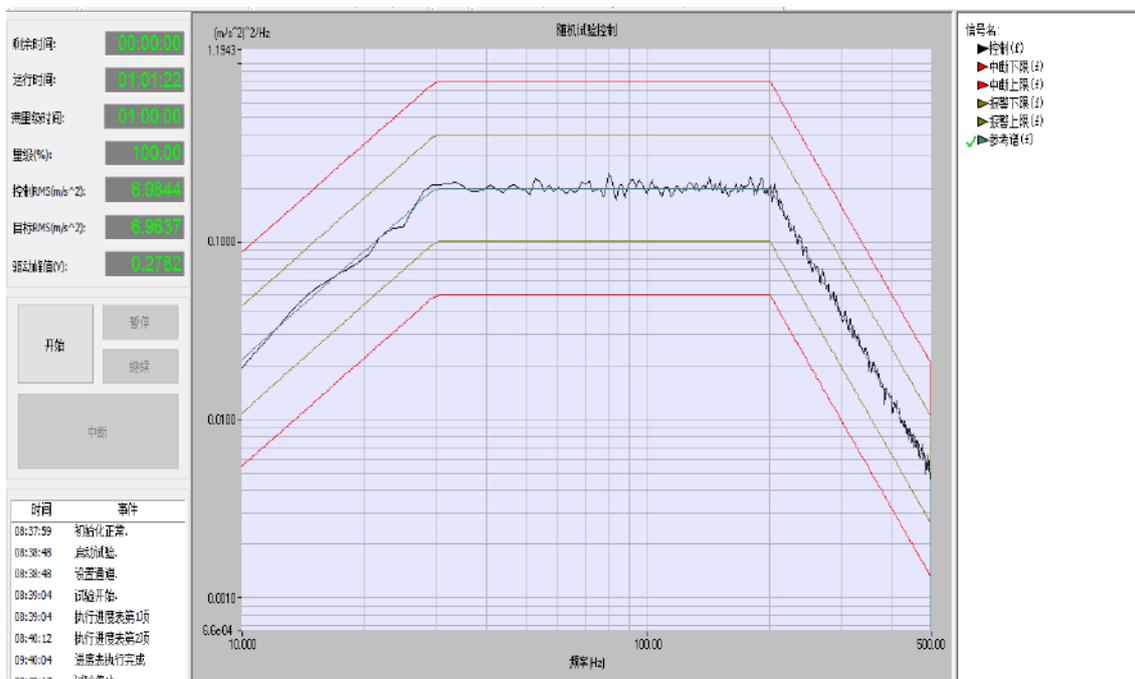
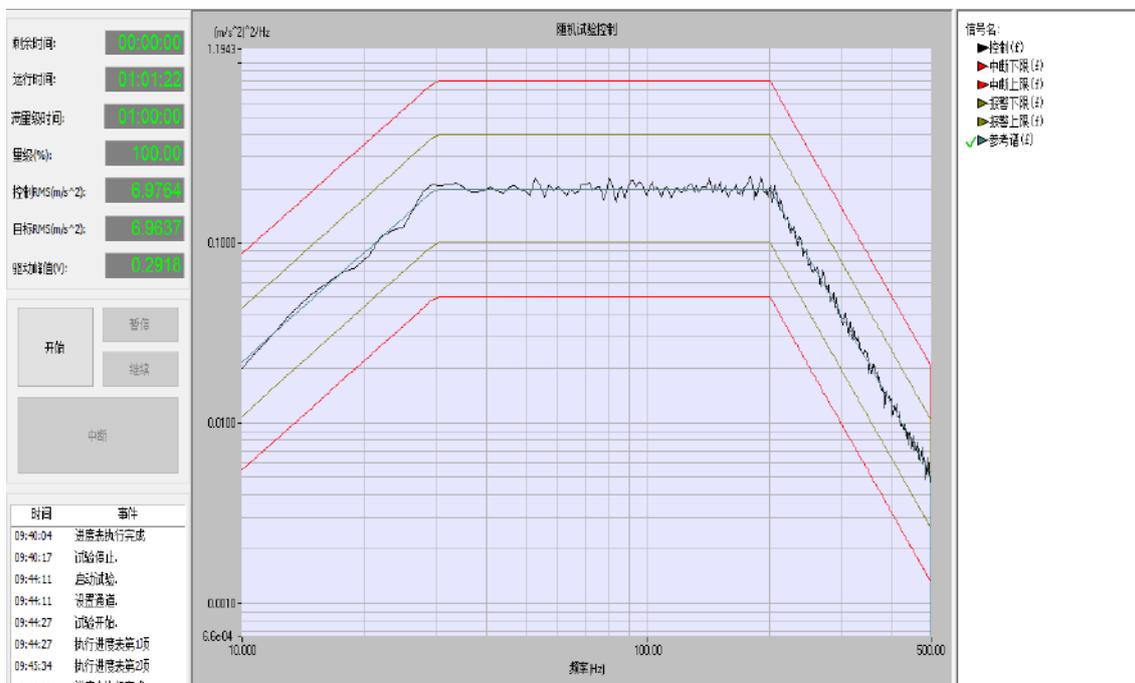
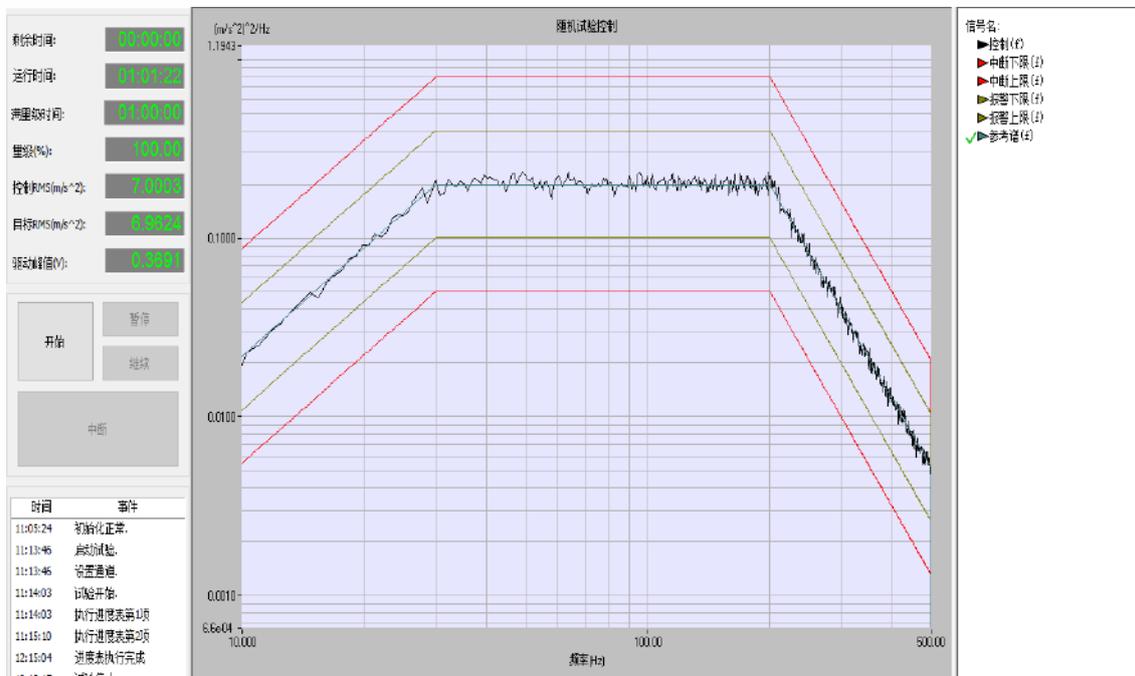
### Test Curve

Frequency (Hz)	PSD(( m/s <sup>2</sup> ) <sup>2</sup> /Hz)	Test direction	Test duration	g rms ( m/s <sup>2</sup> )
10	0.022	X、Y、Z	1h/axis	7.0
30	0.2			
200	0.2			
500	0.0052

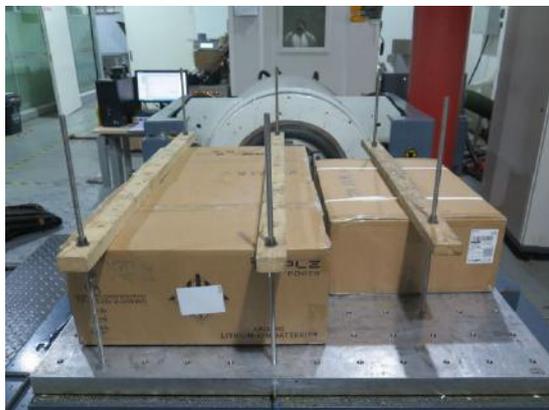
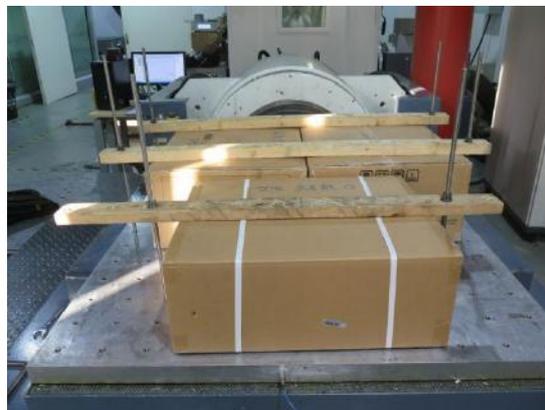
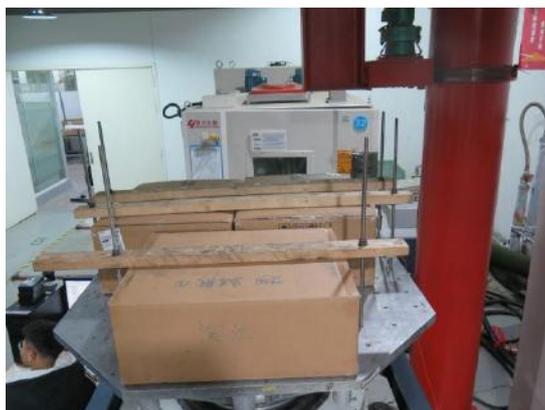
**Test Photo(s)**

Sample No.	Test Result(s)
A2230007151101002	After the test, there was no visible mechanical damage on the sample by visual inspection.

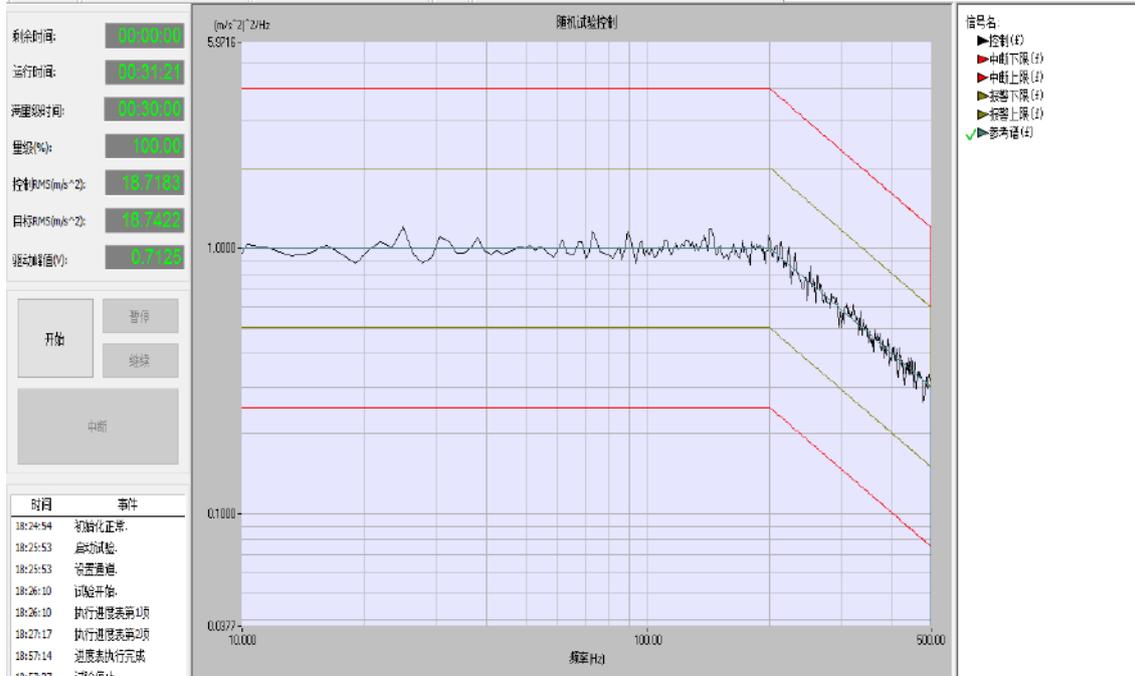
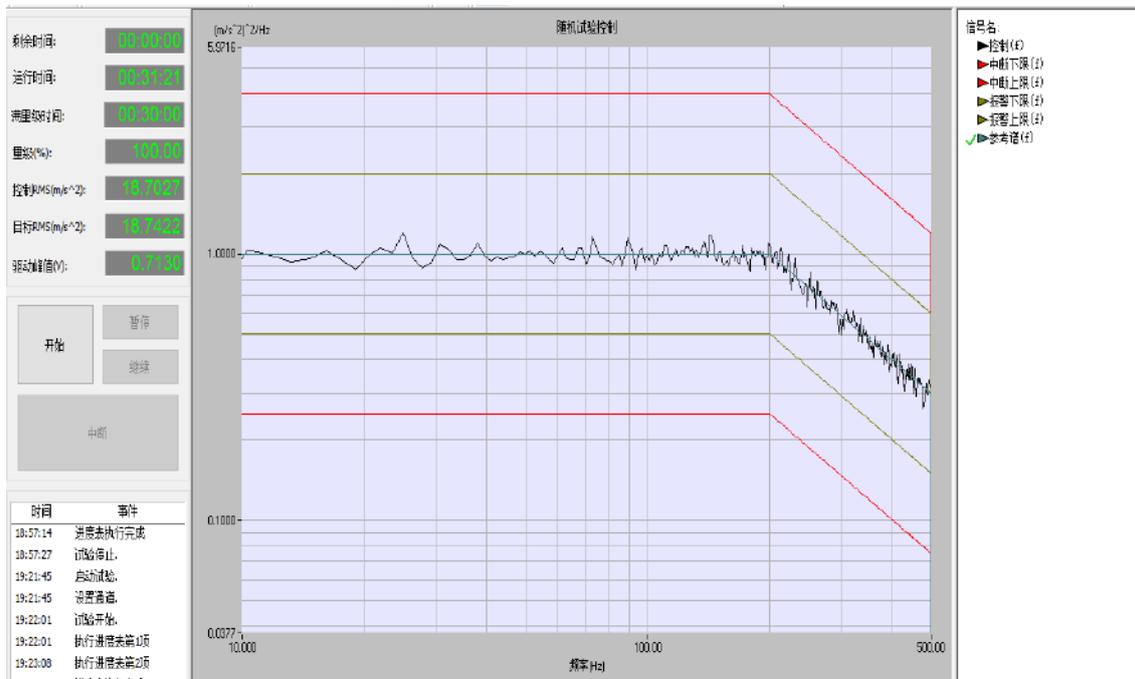
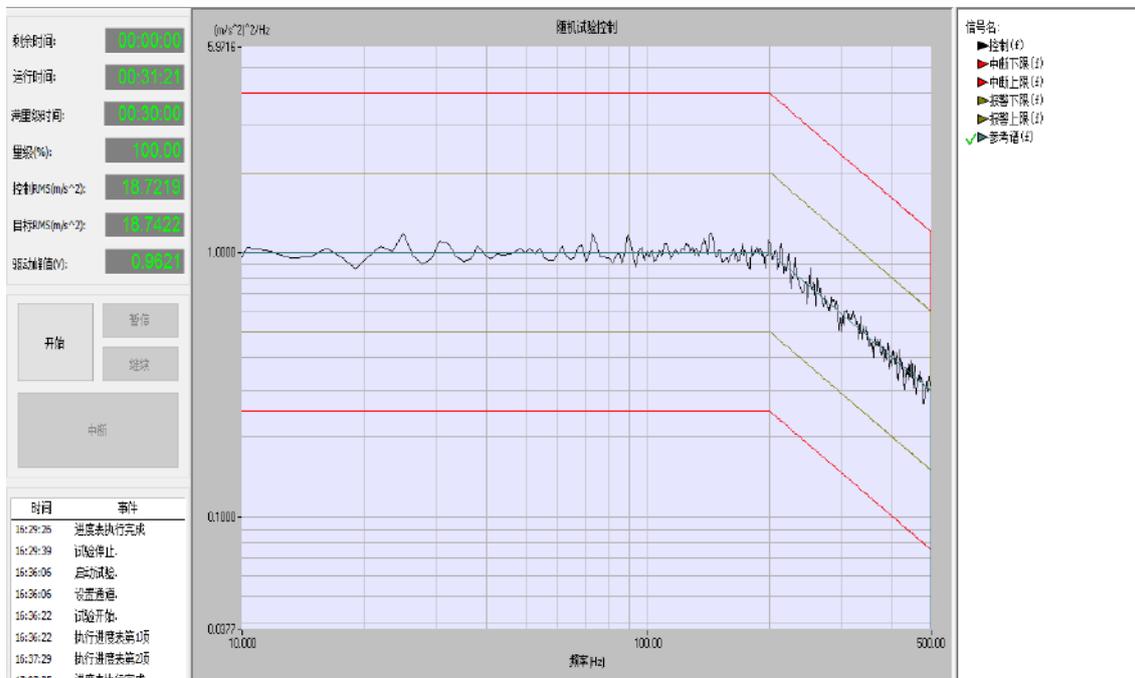
### Test Curve

Frequency (Hz)	PSD(( m/s <sup>2</sup> ) <sup>2</sup> /Hz)	Test direction	Test duration	g rms (m/s <sup>2</sup> )
10	1.0	X、Y、Z	30min/axis	18.7
10	1.0			
200	1.0			
500	0.3

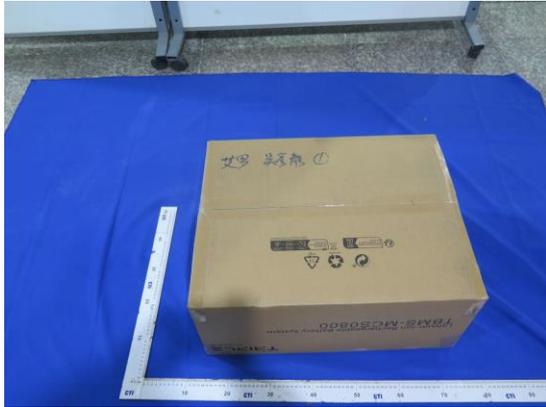
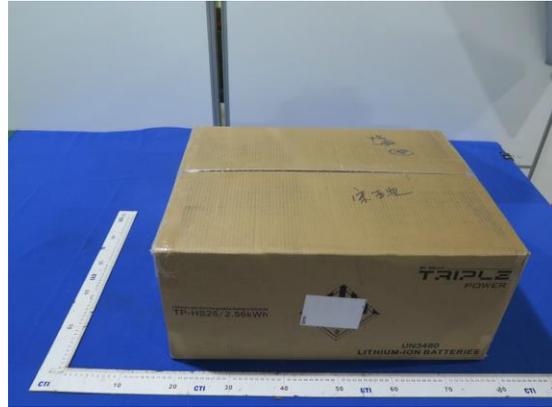
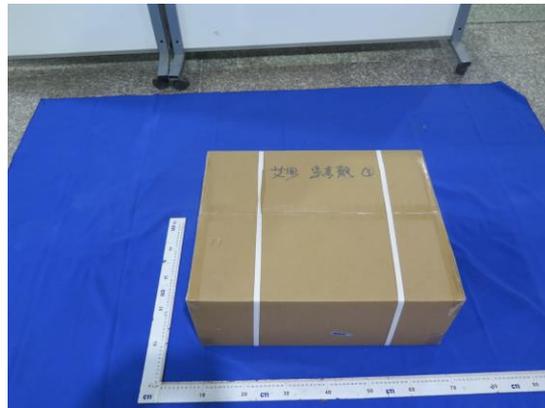
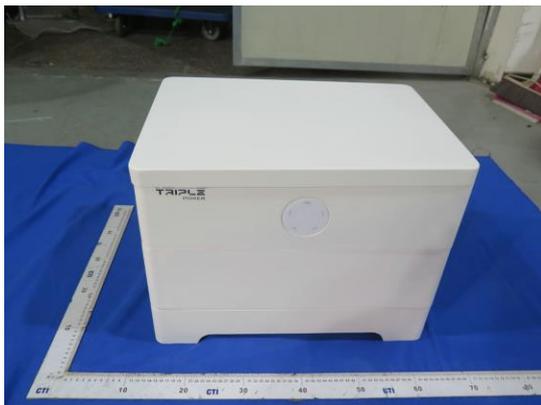
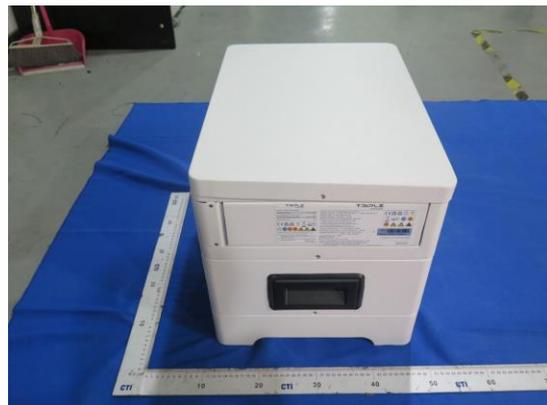
A2230007151101002 (package)

## Sample Photo(s) after the test
